## **Appendix 9 – Equipment Engine 57 Analysis Summary**

### ***Engine 57, Vehicle 6652***

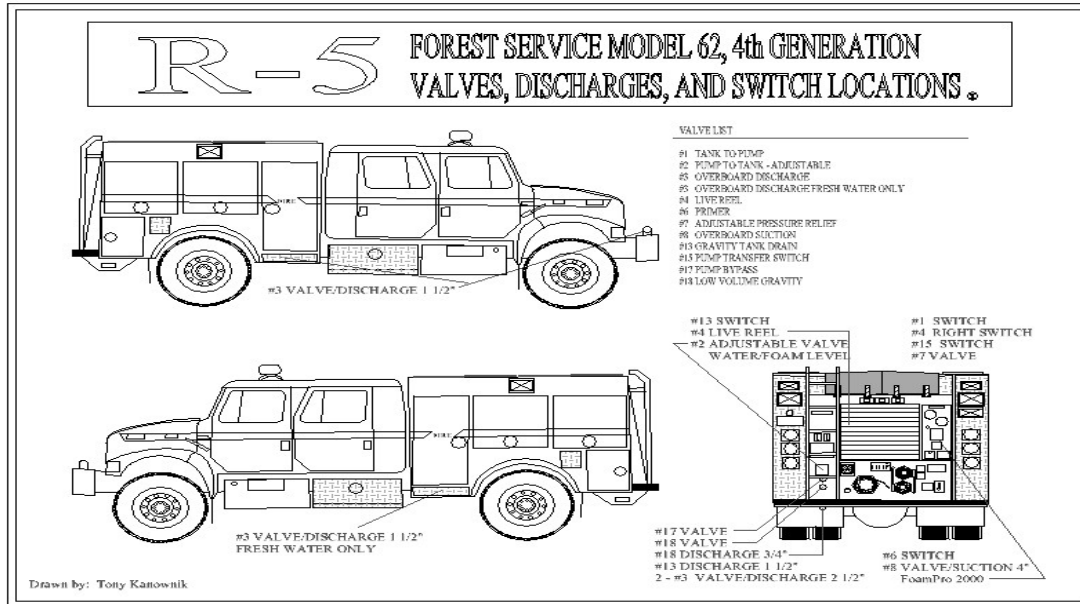
**Equipment Engine Figure 1. ..**

- Model 62 Fire Engine
- Equipped with 1 each 500 gallon water tank, 2 each 20 gallon Class A foam reservoir
- Dual Foam System, Foam Pro 2001
- Darley JMP-500 2-stage pump
